## FLIGHT SERVICE EVALUATION OF THERMAL BARRIER COATINGS BY PHYSICAL VAPOR DEPOSITION AT 5200 H

F. C. TORIZ, A. B. THAKKER and S. K. GUPTA

*Rolls-Royce Inc., 1895 Phoenix Blvd., Suite 400, Atlanta, GA 30049 (U.S.A)*

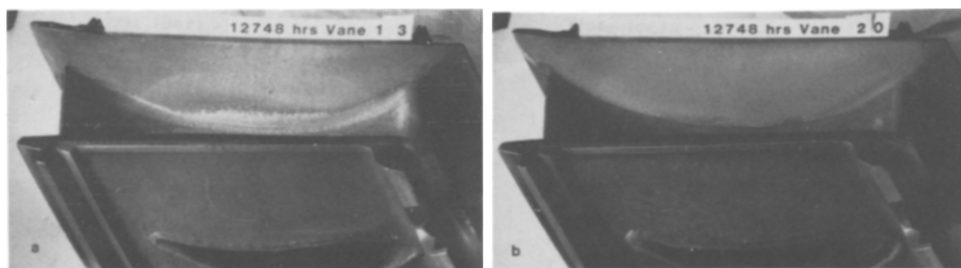
Coating C had significantly less loss, at 10 000 h the average ceramic loss was less than 3% by area. After 10 000 h the loss accelerated such that two vanes had close to 10% loss by 16 000 h. The second-order curve fit used 32 points of data (see Fig. 2). Figure 3(a) shows a vane at 12 800 h with 8% of ceramic loss. Figure 4(a) shows a similar vane at 16 300 h with 10% of the ceramic coating gone. The NiCrAl bondcoat runs cooler than on A or B because of the lower conductivity of the YSZ ceramic, therefore it oxidizes slower. In the fillet radius where the ceramic is minimal, the bondcoat ran hotter and fell off on some vanes early on [1]. References 1 and 3 have more photographs.

Coating E had minimal ceramic loss, the average was less than 1% by area at 10 000 h. Most of those losses were associated with edge effects in the fillet radius; similar to, but less than that shown in Fig. 3(b), where the E-coated vane had 12 748 h. By 16 300 h the average loss was 1%. The worst vane is shown in Fig. 4(b) with 3% area loss. A linear curve fit was adequate with the 60 points of data used to generate the curve fit as also shown in Fig. 2. The bondcoat on all vanes inspected to date was in excellent condition. The coating losses for F were less consistent, with some vanes having very little loss (less than 0.05%), and others as much as 10% at 16 300 h, the average loss (four vanes) was only 3%. The linear curve fit for F in Fig. 2 is for 20 points of data. The bondcoat was in excellent condition, as seen in Fig. 4(c). Because the losses seem to be confined to one or two vanes in each set and in light of the good results other operators [5, 6] have had, we believe some of the coating losses are process related.

Fig. 3. Ceramic coated IPT NGVs at 1200 h into the FSE: (a) coating C, (b) coating E.

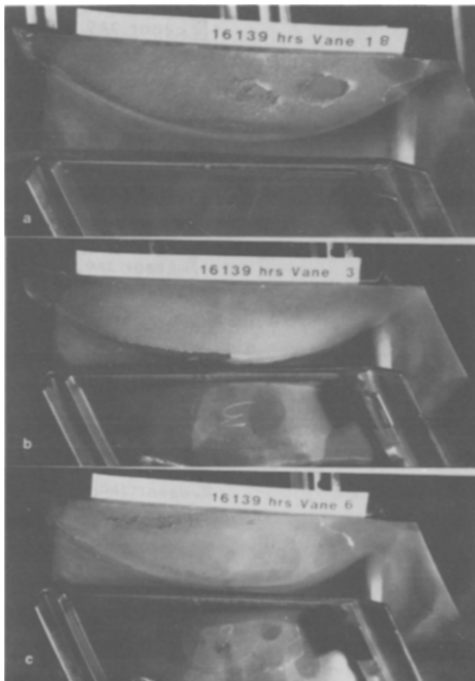
Fig. 4. Ceramic coated IPT NGV at 16 300 h into the FSE: (a) coating C, (b) coating E, (c) coating F.

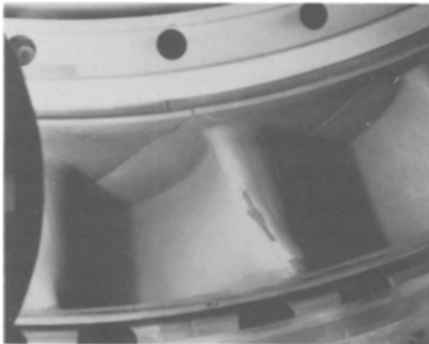
The vanes were inspected at 2500 h when the engine came in for a shop visit, a detailed inspection was not possible as the module containing the IPT vanes was not taken apart at that time. A photograph of a vane prior to service is given in ref. 7. This IPT vane set appeared to have suffered considerably more erosion than any engine inspected to date, even uncoated vanes had visual signs of metal removal on the leading edge (LE) airfoil. Erosion was evident on all of the PVD vanes, but more so on three that had distinct lines outlining the eroded areas, none were eroded through to the bondcoat. Erosion to the platform coating was not noticeable. Two vanes had spalling on the LE, which may have been initiated by small dings which occurred in shipping, one vane (number 2) is shown in Fig. 7. Two vanes had minor spalling on the platforms. The IPT castings are fairly rough, especially on the platforms, and may have reduced the adhesion quality of the PVD coating which performs better on a smooth surface. Some edge chipping was seen, but most of it occurred prior to installation. The coating on the pressure side of all five airfoils was in excellent condition. No mud flat cracking or crazing was evident. The surface finish appeared to be as installed, except on the eroded LEs. The parts did not come out of the engine, so the surface finish was not measured. Table 4 summarizes the area losses.

Fig. 7. Condition of PVD YSZ coated IPT vane at 2500 h into the FSE program.

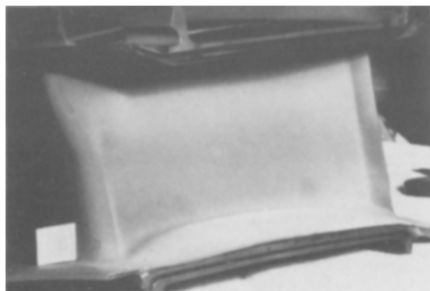
More recently the engine was removed again and this time the module was taken apart, the PVD coated vanes having 5188 h and 2629 cycles flight experience. There was no further evidence of erosion; however, there was spalling on all the LE coated vanes. The LE spalling was typically  $0.38 \text{ cm} \times 3.8 \text{ cm}$  along the vertical LE of the vane. Vane number 3 is shown in Fig. 8. The average area loss at the LE is  $0.64 \text{ cm}^2$ . The platform loss increased only slightly to 1.5% by area. The area summary loss is given in Table 4. The pressure side airfoils were still in excellent condition. No mud flat cracking or crazing was seen (Table 4).

Fig. 8. Condition of PVD YSZ coated IPT vane at 5200 h into FSE program.
