Thermal Barrier Coatings for Jet Engines

F. C. TORIZ
Member ASME
Senior Engineer
Rolls-Royce Inc.
Atlanta, Georgia

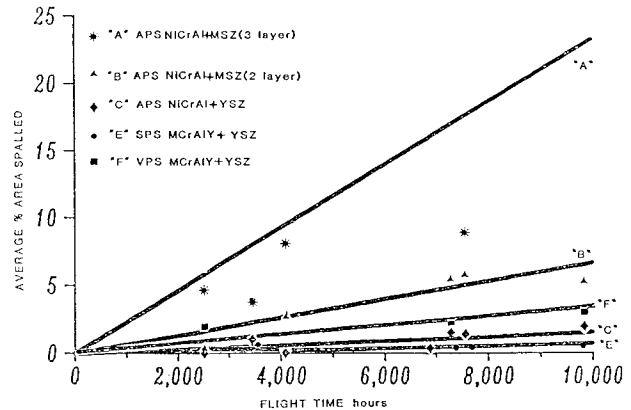
By measuring the area of coating loss on each platform, and dividing it by the original area for each inspection period, we get the percent coating loss for each coating versus time. Figure 8 shows the average area loss for coatings A through E. The smooth curves were obtained from a regression analysis of the data. It shows the improvement achieved by using high density bond coats such as those obtained by VPS and SPS.

Figure 8 IPT NGV Coating Loss (% area) with Time.

The order of ranking of the TBCs tested in the harsh turbine environment does not necessarily follow the order of figure 8. Coating "C" lost bond coat on several vanes where not covered by ceramic. Toriz et al [1] has shown the bond coat loss as early as 4100 hours. This indicates that the bond on "C" is at or near its oxidation temperature limit, depending if it is on a hot or cool vane. It also indicates that "C" will not be very useful at higher temperatures.

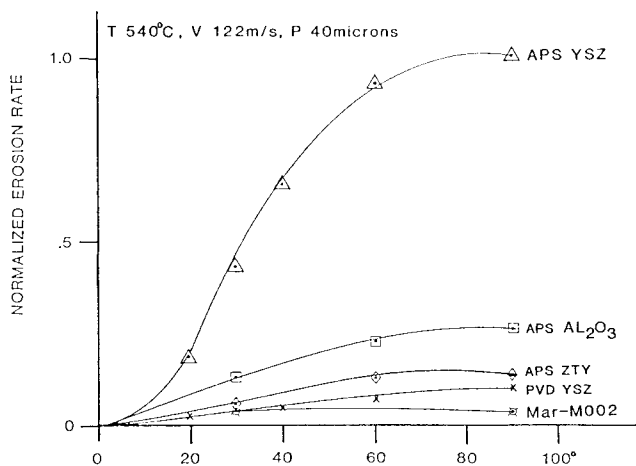
It was found that E_r increases with increasing angles (A) of particle impingement. This was particularly true with the standard YSZ system where E_r at 90° was 5 times higher than at 20° as can be seen in figure 10. This is consistent with the traditional response of "brittle materials". The bare metal E_r is lower at 90° than it is at 30° , which is the traditional response for "ductile materials".

Figure 10 The Effect of Impingement Angle on Erosion.

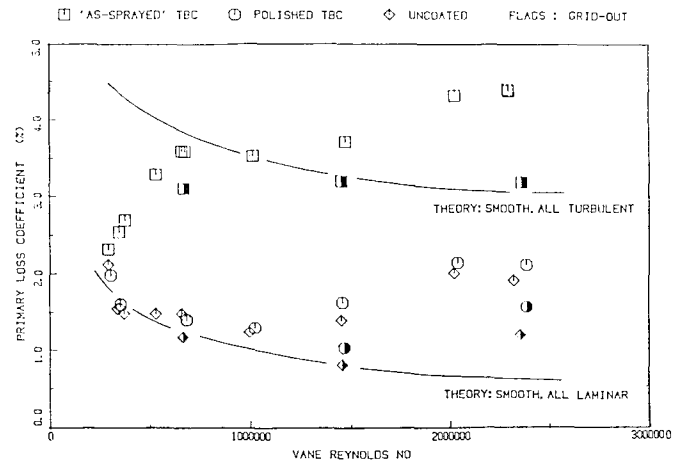
Pressure variations were measured through a wake of each variant at the design condition. The processed data is shown as a plot of "primary loss coefficient" $(1-\eta)$ versus Re in figure 18. The majority of data in this figure correspond to nominally 4% inlet turbulence intensity. The influence of free stream turbulence on primary efficiency is simply tested at a few selected conditions.

Figure 18 Profile Loss Measurements.
