## FLIGHT SERVICE EVALUATION OF THERMAL BARRIER COATINGS BY PHYSICAL VAPOR DEPOSITION AT 5200 H

F. C. TORIZ, A. B. THAKKER and S. K. GUPTA

*Rolls-Royce Inc., 1895 Phoenix Blvd., Suite 400, Atlanta, GA 30049 (U.S.A)*

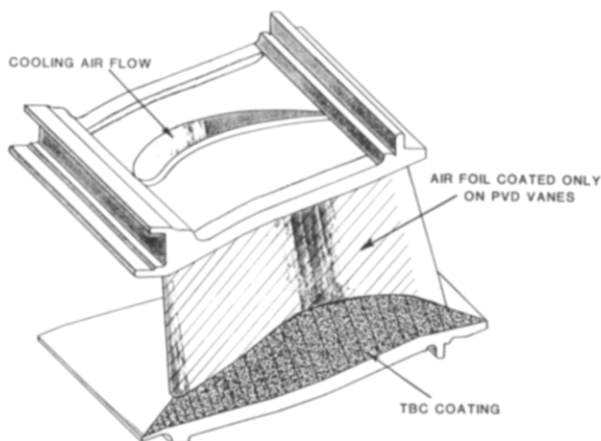
After considerable review, the RB211-22B intermediate pressure turbine (IPT) NGV was chosen as the FSE component (see Fig. 1). Prior work on a bench engine had shown that the IPT NGV platform application was considerably more demanding than the combustion chamber environment.

The coatings in phase I were applied only to the inner diameter pressure side platform area. In phase II, the pressure side airfoil of some vanes were coated as shown by the crosshatching in Fig. 1. The nickel base vane is nominally 20 cm long, 7.6 cm wide and 10 cm tall (8 in  $\times$  3 in  $\times$  4 in). Eight TBC systems were evaluated (Table 1). The coatings were given designations; A was three-layer magnesium zirconate (MSZ), the standard combustor coating. Coating B was two-layer MSZ, without the cermet (a NiCrAl and

Fig. 1. RB211 IPT NGV showing location of TBCs patches.

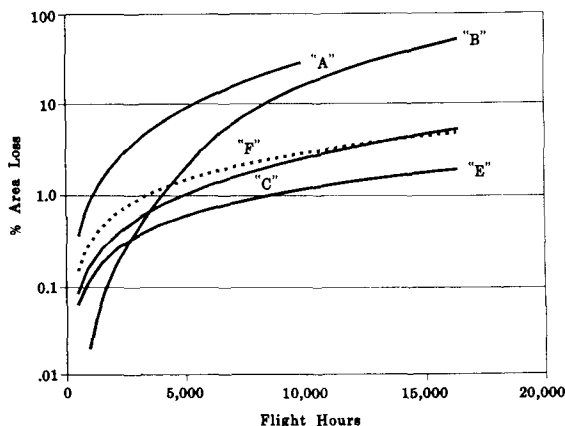
Coating A lost the most amount of coating (spalling). It was removed from the program at 9800 h with an average area loss of 31% [3]. Twenty data points were used to generate a second order regression analysis curve fit of the data for coating A, which is plotted on semi-log paper in Fig. 2. Bondcoat was missing in the fillet radius of these vanes as early as 2500 h [1].

Fig. 2. Loss of ceramic coating (percentage area) on IPT NGVs with time (see Table 1 for coating identification).

Coating B was significantly better than A, but was still not acceptable. The area loss was negligible prior to 3500 h, and only 16% at 10 000 h. By 16 000 h the average loss was close to 50%. Thirty-one points were used to determine the second-order curve as shown in Fig. 2. Bondcoat was missing in the fillet radius at 2500 h [1].

Coating C had significantly less loss, at 10 000 h the average ceramic loss was less than 3% by area. After 10 000 h the loss accelerated such that two vanes had close to 10% loss by 16 000 h. The second-order curve fit used 32 points of data (see Fig. 2). Figure 3(a) shows a vane at 12 800 h with 8% of ceramic loss. Figure 4(a) shows a similar vane at 16 300 h with 10% of the ceramic coating gone. The NiCrAl bondcoat runs cooler than on A or B because of the lower conductivity of the YSZ ceramic, therefore it oxidizes slower. In the fillet radius where the ceramic is minimal, the bondcoat ran hotter and fell off on some vanes early on [1]. References 1 and 3 have more photographs.

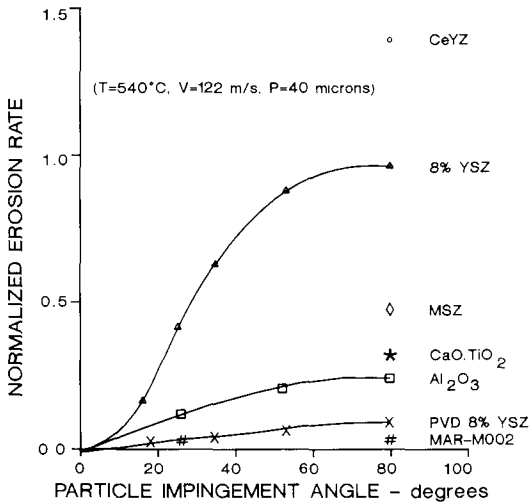
An erosion test program run at the University of Cincinnati [7, 9] indicated that PVD YSZ was 10 times more erosion resistant than the standard APS YSZ at a  $90^\circ$  impingement angle. Figure 5 shows the relative erosion rates of several ceramic coatings as a function of impingement angle. At low angles of attack, such as on combustors or vane platforms, PVD is only a 2 times improvement over APS YSZ. But the benefit increases with angle, so that coatings applied to flow path airfoils will see life improvements of up to 1000% (at  $90^\circ$ ). By looking at the erosion rate at  $90^\circ$  in Fig. 5, one can obtain the erosion ranking for several different TBC materials, more are found in ref. 7.

Fig. 5. The effect of impingement angle on the erosion of engine materials. Erosion ranking for six ceramics (five APS) and one metal (substrate) given at 90° impingement angle.

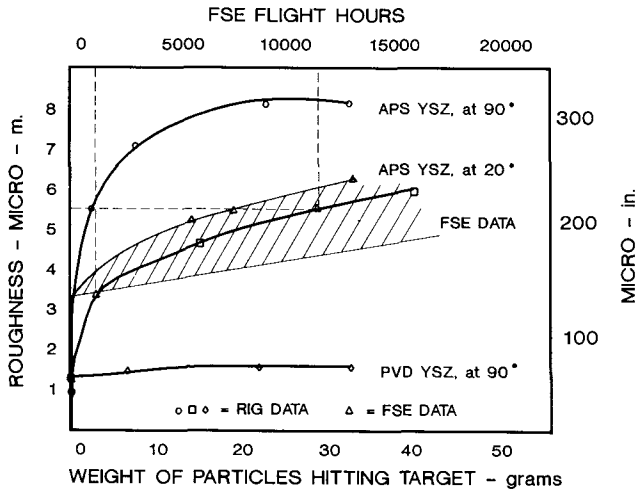
The erosion test program [7, 9] also showed that PVD TBCs have a better surface finish retention with time than the APS TBCs. The as sprayed YSZ was very rough, it measured over  $7.7 \mu\text{m}$ . Most of the erosion test coupons were polished to about  $1 \mu\text{m}$  ( $40 \times 10^{-6}$  in) before testing. The PVD YSZ coupons were  $1 \mu\text{m}$  ( $40 \times 10^{-6}$  in) as received. When erosion tested, the polished standard YSZ decayed from  $1.2 \mu\text{m}$  ( $50 \times 10^{-6}$  in) to over  $7.7 \mu\text{m}$  ( $300 \times 10^{-6}$  in) at a 90° impact angle. At a 20° angle the deterioration was much slower, and probably compares to that of the FSE NGV platforms. The PVD coating did not deteriorate much even after 30 g of particles; as can be seen in Fig. 6.

Now to correlate this with the FSE program. Vanes coated with A, B, C and F (Table 1) were polished. Their roughness increased with flight time, as shown in Table 3. None of the E-coated vanes were polished and they stayed at about  $7.7 \mu\text{m}$  up to 12 800 h. From Table 3 we see that it took 9800 h to deteriorate from a 2.8 to  $5.1 \mu\text{m}$  finish at low angles of attack. In Fig. 6 this decay takes approximately 25 g; so we have the rough relationship that 25 g in wind tunnel testing is roughly equal to 10 000 FSE h. Using this relationship, by 8000 h (20 g) the leading edge of an airfoil (at 90°) would have a surface finish of about  $7.7 \mu\text{m}$ . Its surface finish would be  $5.1 \mu\text{m}$  ( $200 \times 10^{-6}$  in) in only 1000 h. The PVD YSZ however, will still have a good surface finish  $1.5 \mu\text{m}$  ( $60 \times 10^{-6}$  in) at 13 000 h (32 g). The FSE experience data band is overlaid on Fig. 6. Airfoil measurements further indicate that the PVD coating has a better surface finish ( $130 \times 10^{-6}$  in) than the bare metal ( $185 \times 10^{-6}$  in) at 5200 h (see Table 3).

Fig. 6. Ceramics surface roughness variations with erosion-time from rig testing correlated to surface finishes experienced in the FSE program.
